## SERVICE AND SUPPORT AT PACE

Patrick Mardaymootoo is the service manager at Pace Cranes. After initially gaining his Cranesafe accreditation at Pace and after 25 years, Patrick left to be a full time CraneSafe inspector. Seven years later, he moved back to Pace Cranes. Mardaymootoo explains how focused the business is on service and support.

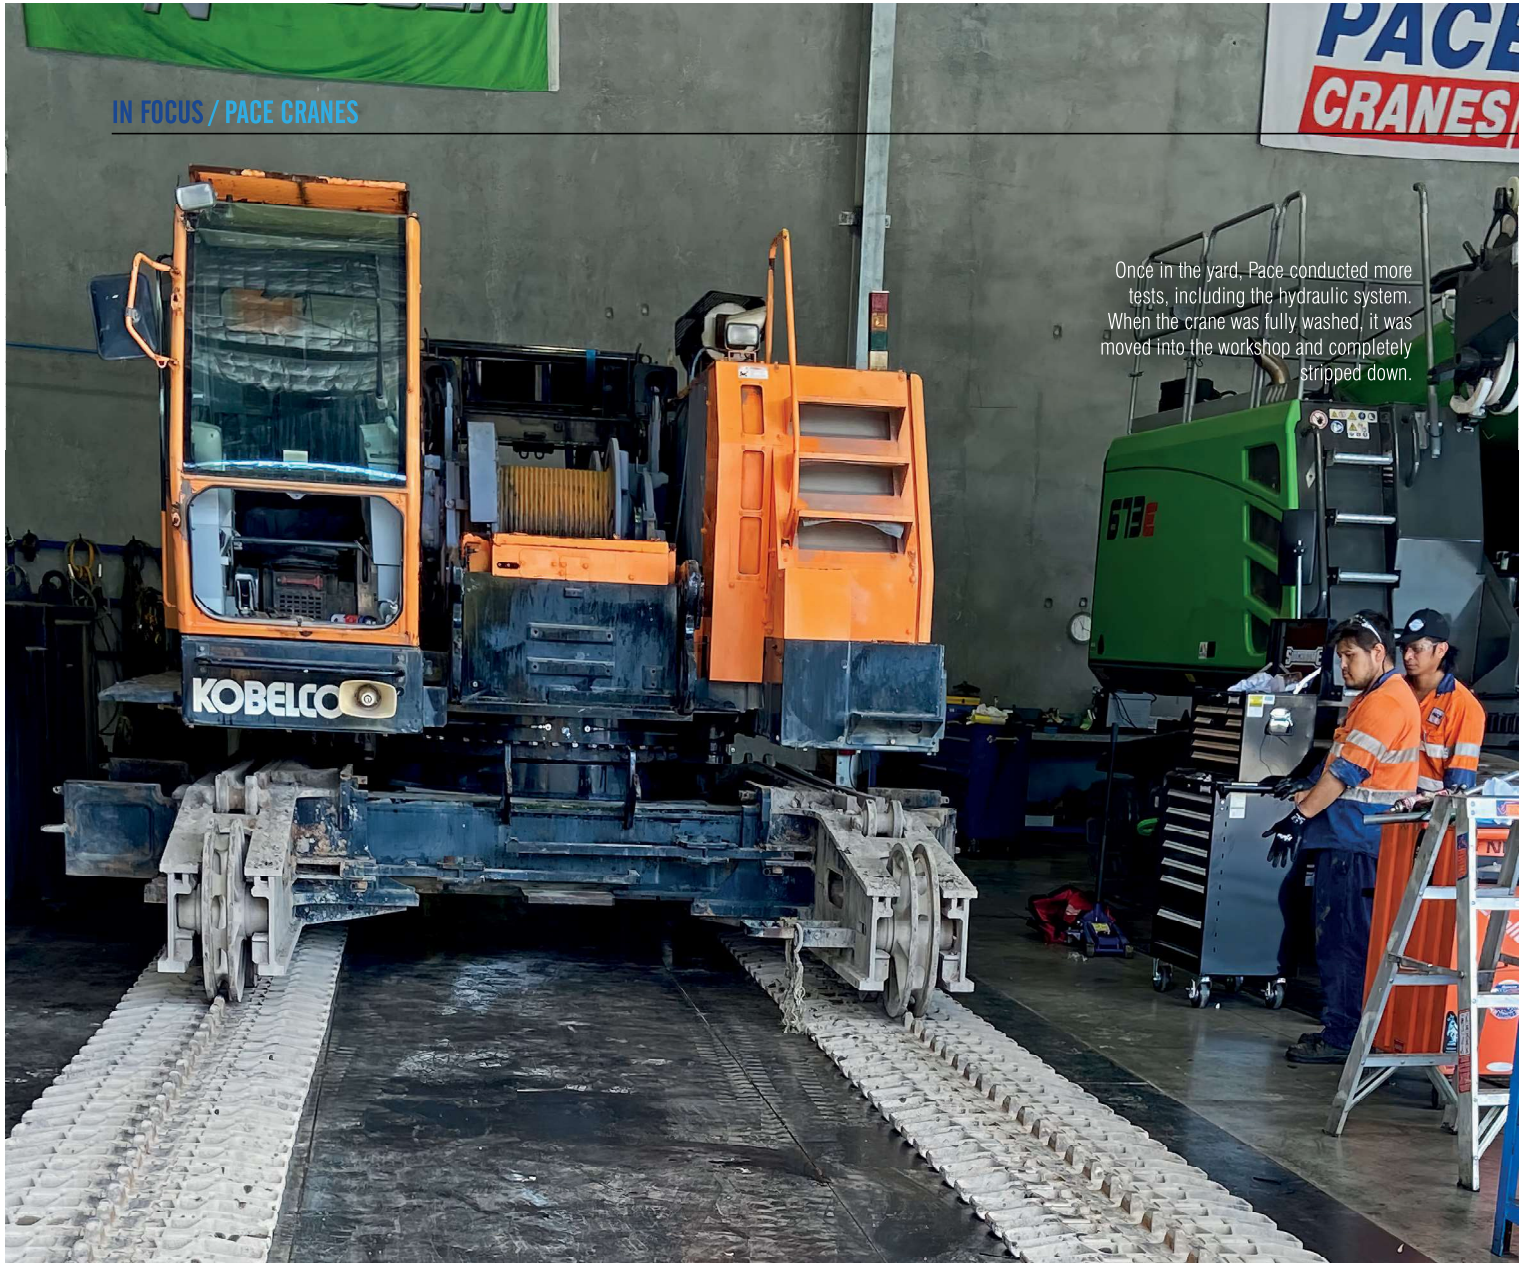
Once in the yard, Pace conducted more tests, including the hydraulic system. When the crane was fully washed, it was moved into the workshop and completely stripped down.

"Once in the yard, we conducted more testing, including testing the hydraulic system. When the crane was fully washed, we moved the crane into the workshop and completely stripped it down, including all the winches and the drive systems for the tracks, and everything was brought right up to date.

The internal features of the cabin were worn and basically unserviceable, so we replaced everything and took the interior back to its original finish as if it were brand new. When we had finished our work, we sent the crane back to our painters where they sand blasted the crane, completed panel and rust repairs, and then painted the crane," he said.

"Whilst the crane was stripped down all the lattice boom sections were sand blasted and all the lacings which required replacing were replaced. The crane was NDT [non-destructive testing] crack tested. The various ropes, including the winch and luffing ropes, were replaced. When we completed the overload test was undertaken at 25 per cent over, as per the Australian standard, and all winches were tested at 10 per cent over.
